## Locked inspection report

### Maple Court Apartments - Unit 2B

218 Chestnut Ave, Springfield, IL 62701

Move-in inspection - template: Move-in checklist

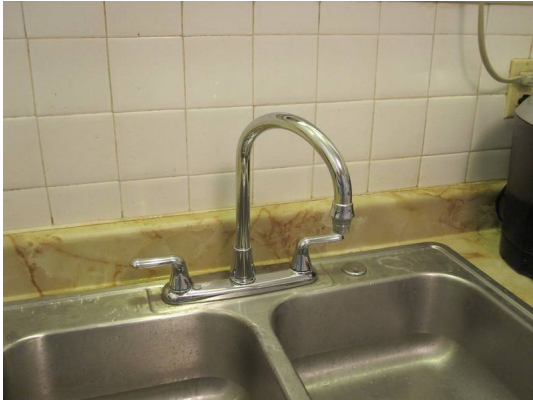
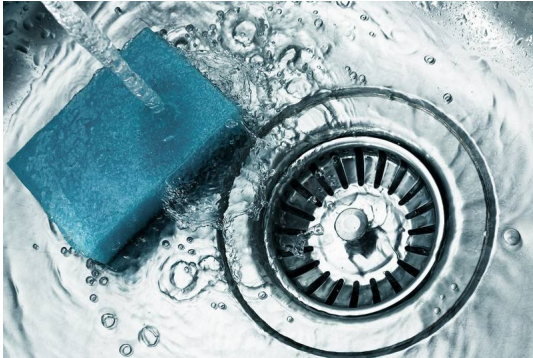
Sink, faucet and disposal - Good

Minor scratch inside the basin. Disposal runs without rattle.

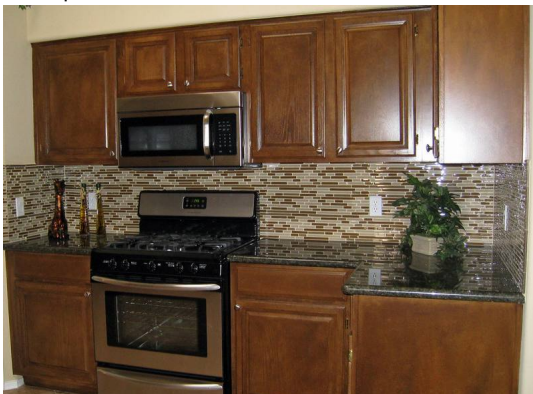
Countertops and backsplash - Excellent

No chips. Seams sit flush.

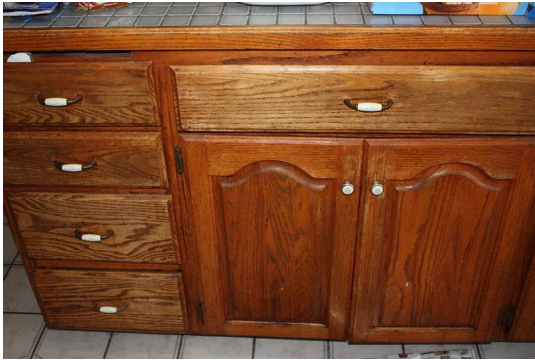
### Cabinet doors and drawers - Fair

Two doors misaligned. Handle loose on the upper left.

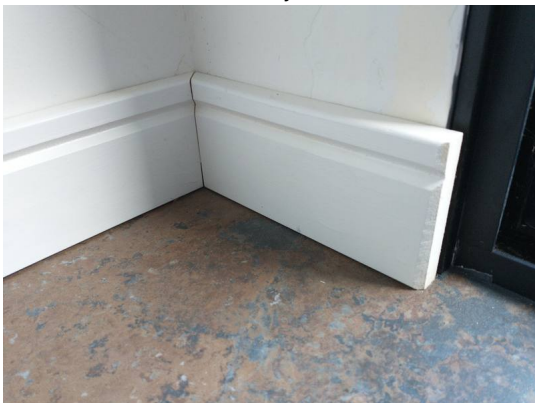
### Floor and skirting - Good

One hairline crack in the tile by the door.

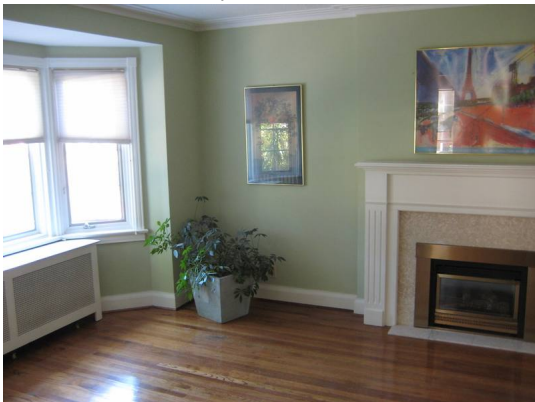
Walls, ceiling and paint - Good

Scuffs behind the sofa position.

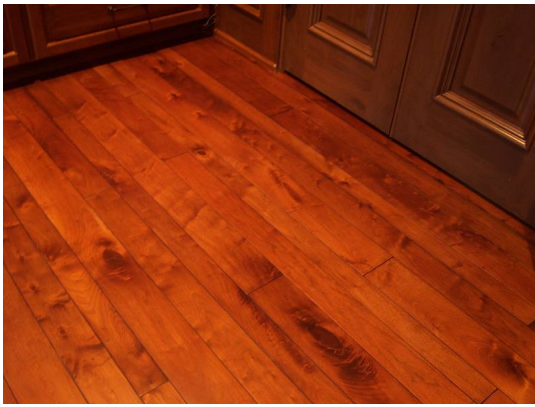
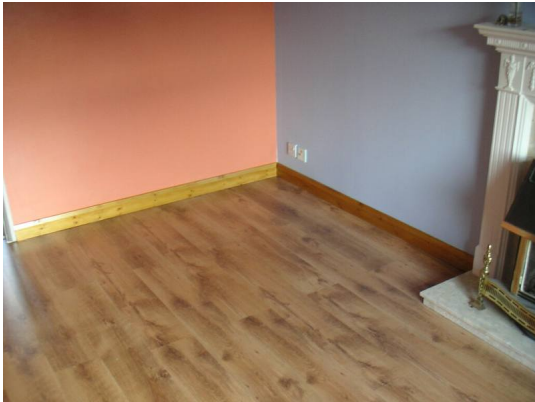
### Floor covering - Excellent

No lifting at the seams. Cleaned before handover.

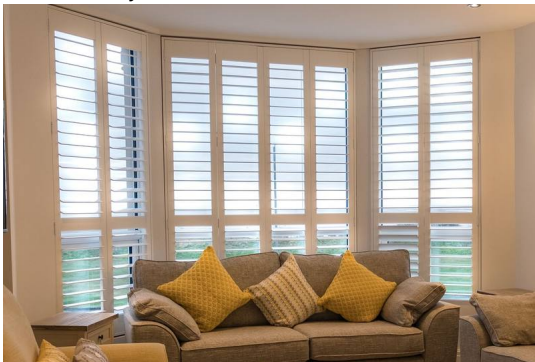
Windows, latches and blinds - Fair

Blind cord frayed. Left latch stiff.

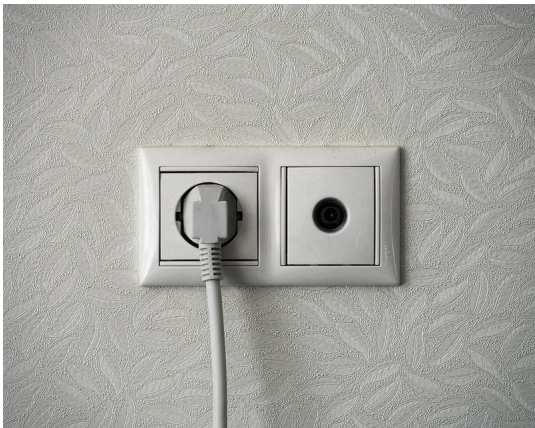
Power outlets and switches - Good

Six outlets tested with a socket tester.

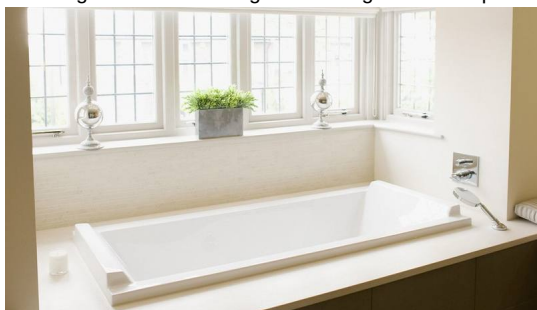
Shower, tub and caulking - Fair

Caulking discoloured along the tub edge. No soft spots underfoot.

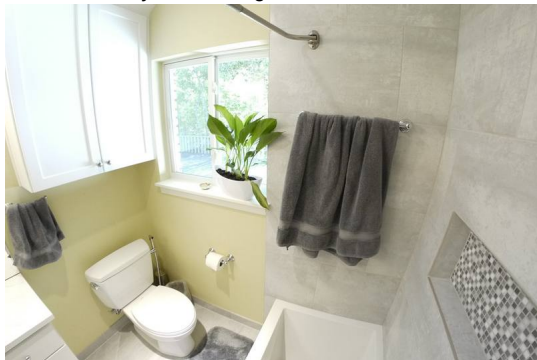
Toilet and cistern - Good

Flushes cleanly. No rocking at the base.

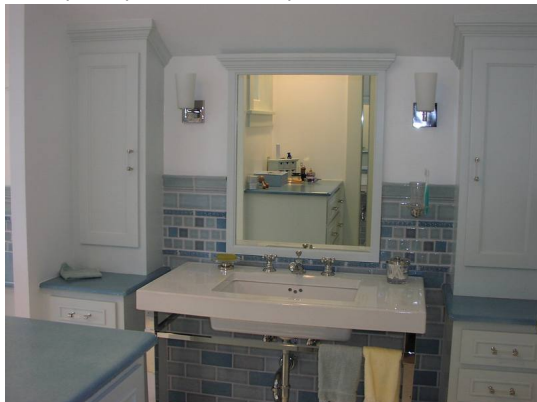
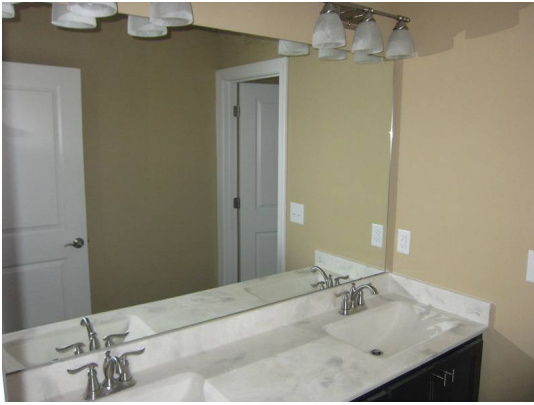
Basin, vanity and mirror - Excellent

No chips. Tap runs without drip.

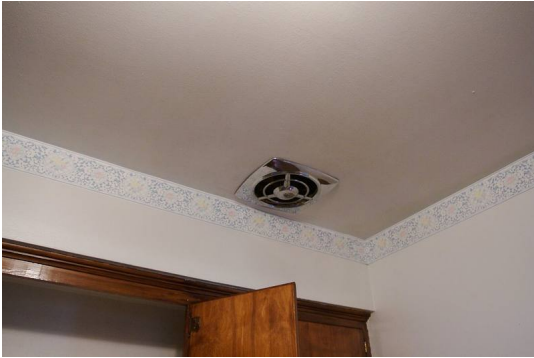
#### Extractor fan - Poor

Runs, but does not clear steam. Suspect a blocked duct - needs a contractor.

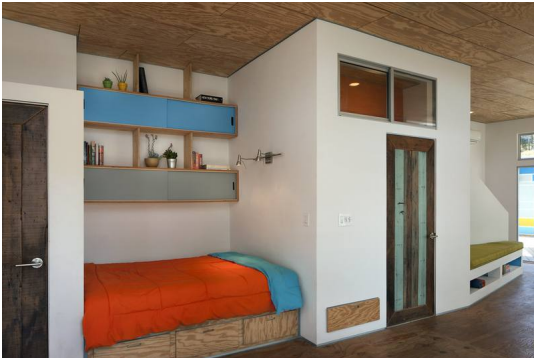
Walls, ceiling and paint - Excellent

Freshly painted. No marks found.

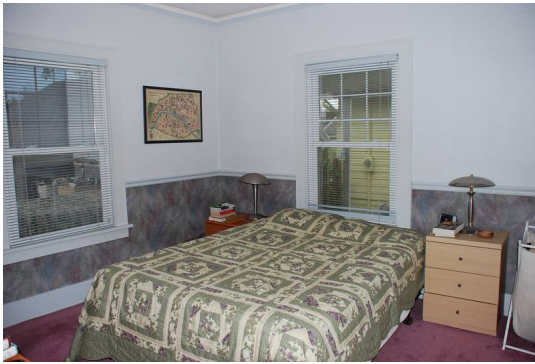
#### Carpet and flooring - Good

Light wear at the threshold.

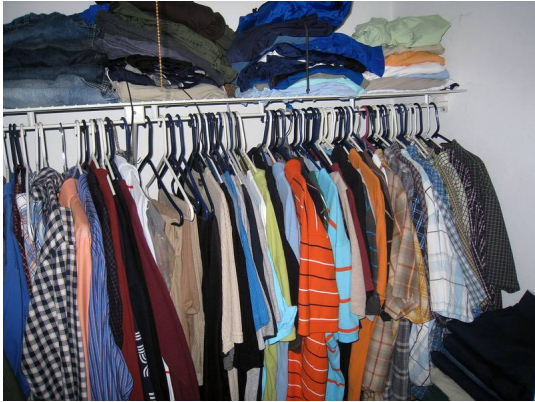
Wardrobe doors and rails - Good

Rail secure. One roller noisy on the left door.

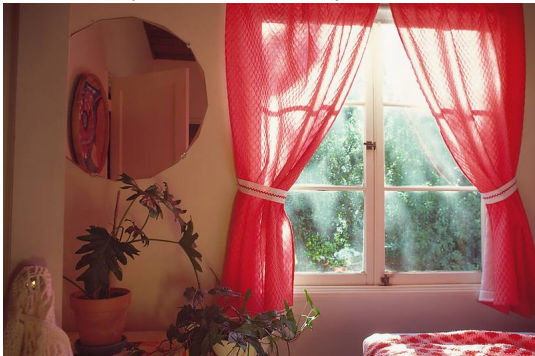
Window and curtains - Excellent

Seal intact. Opens and locks cleanly.

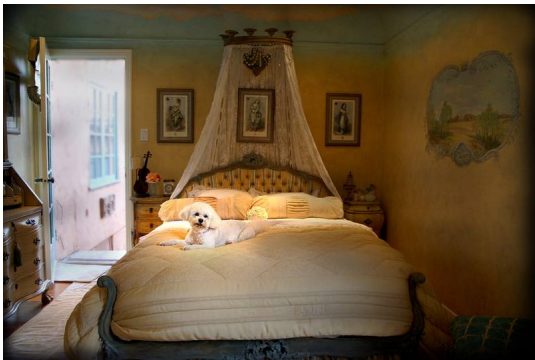
Walls, ceiling and paint - Fair

Blu-tack marks above the desk position.

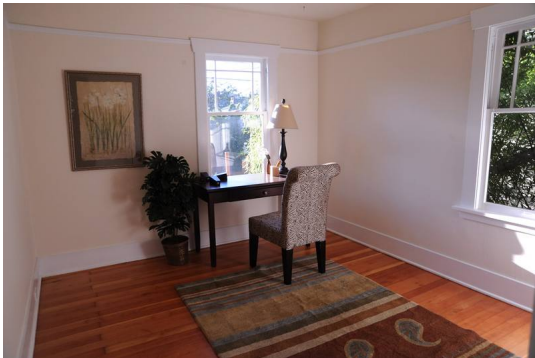
photo 10:35:20 - 39.7817 N, 89.6501 W  
 Carpet and flooring - Good  
 One small stain under the window.

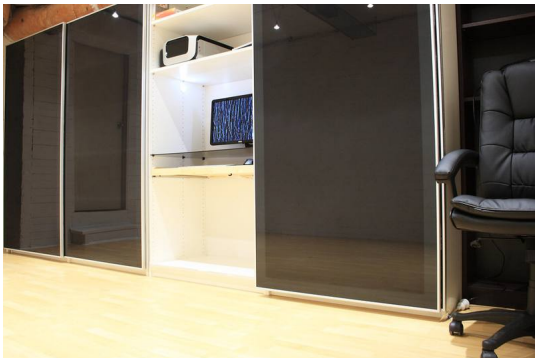
photo 10:35:58 - 39.7816 N, 89.6502 W  
 Wardrobe doors and rails - Excellent  
 No faults found.

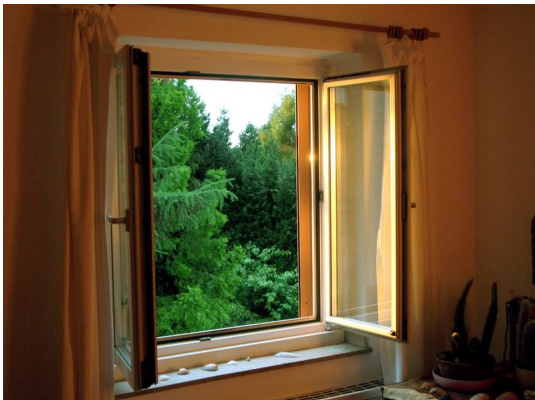
photo 10:36:30 - 39.7817 N, 89.6501 W  
 Window and curtains - Good  
 Curtain track secure. Curtains cleaned.

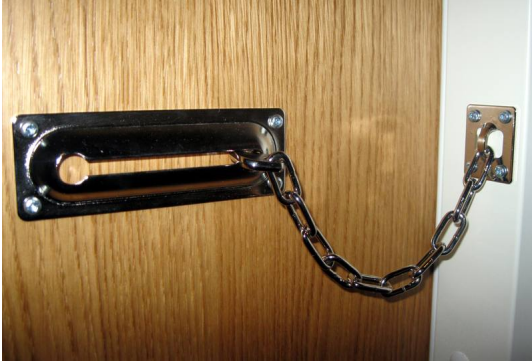
Front door, lock and chain - Good

Deadbolt engages. Chain missing one screw.

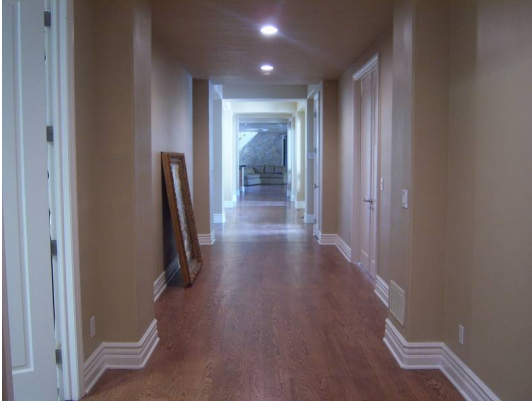
Walls and skirting - Good

Minor scuffs from moving furniture.

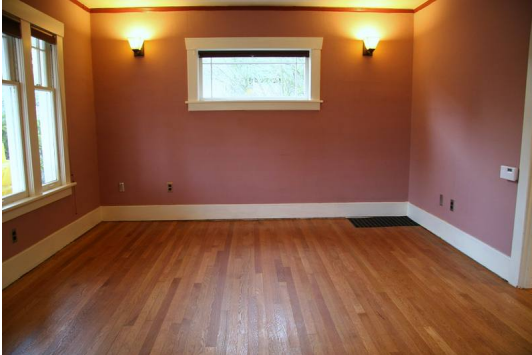
Floor covering - Excellent

No lifting at the threshold.

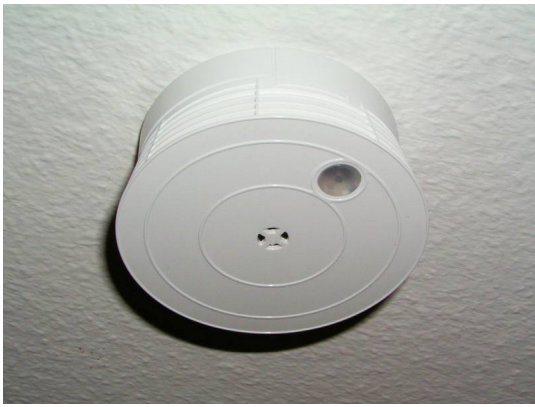
Smoke and heat alarms - Good

Both tested from the test button. Heat alarm sounded twice.
